J.C. BACON DAM

NDI I.D. NO: PA-260

PHASE I INSPECTION REPORT  
NATIONAL DAM INSPECTION PROGRAM

MAY 1979

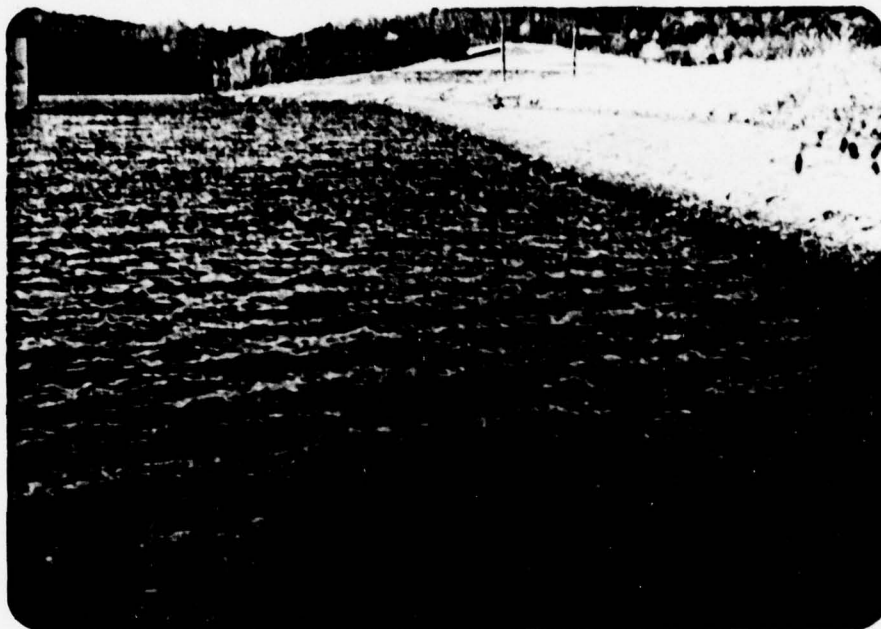
Upstream Face

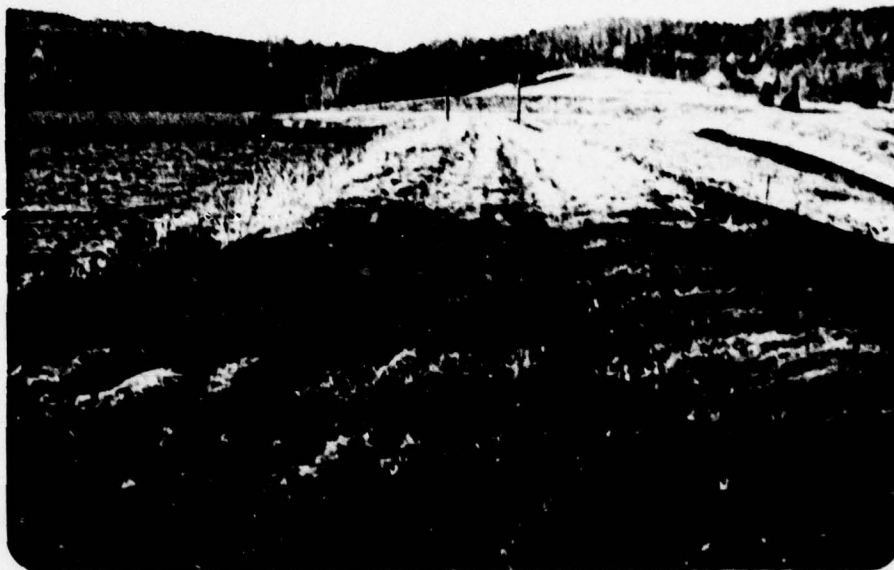
Photograph No. 1  
Crest (looking north).

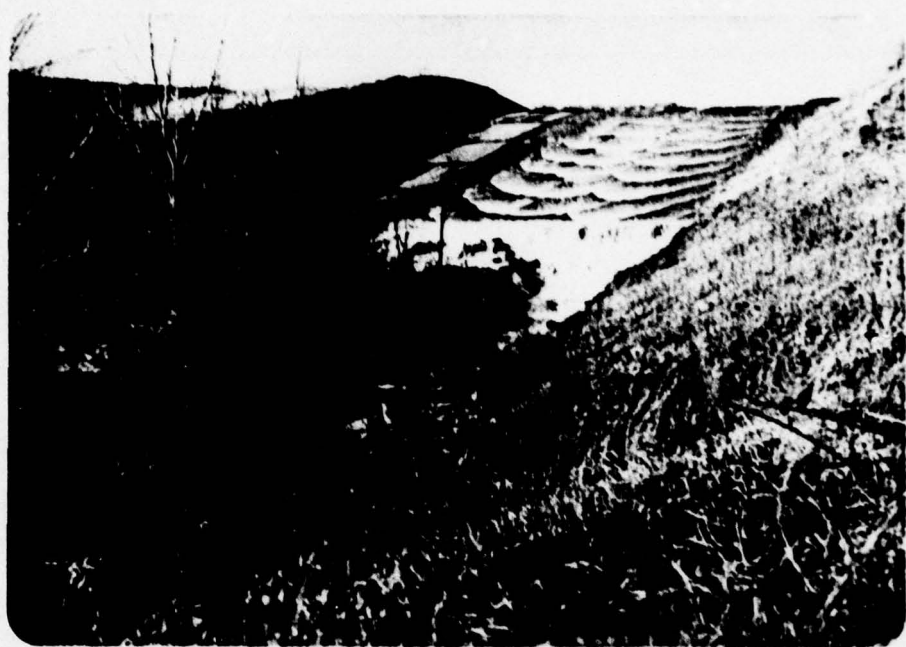
The most significant condition noted was the presence of brush and debris in the spillway approach channel. This condition is considered to pose a potential for obstruction of flow through the spillway. The rocks at the downstream end of the outlet conduit constitute an obstruction of flow through the outlet works.

Photograph No. 3  
Spillway crest. Note debris at crest.

It was observed that debris and brush have accumulated at the spillway approach channel. This area should be cleared to avoid obstruction of flow through the spillway.

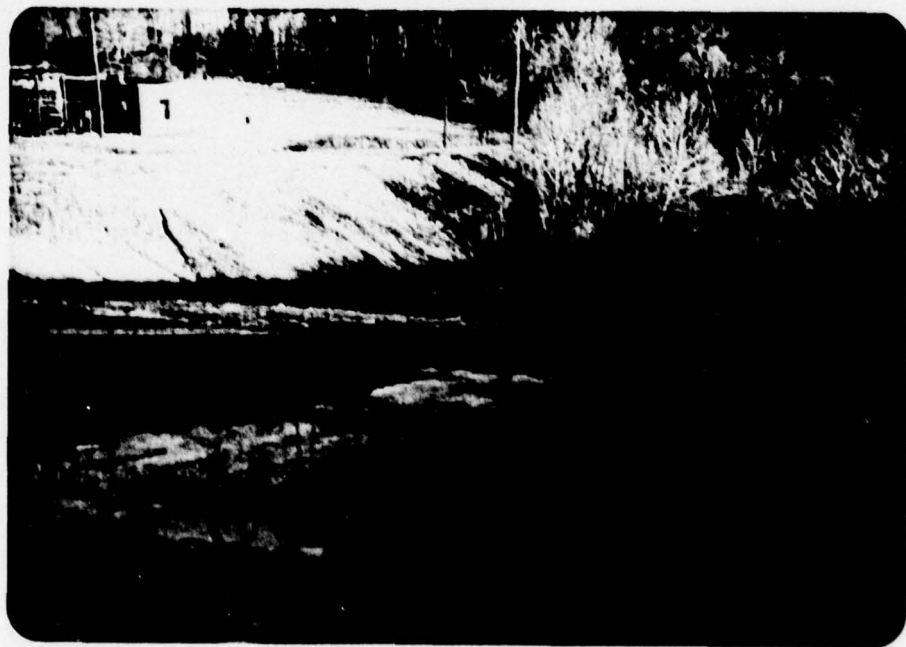
Photograph No. 4  
Spillway discharge channel.

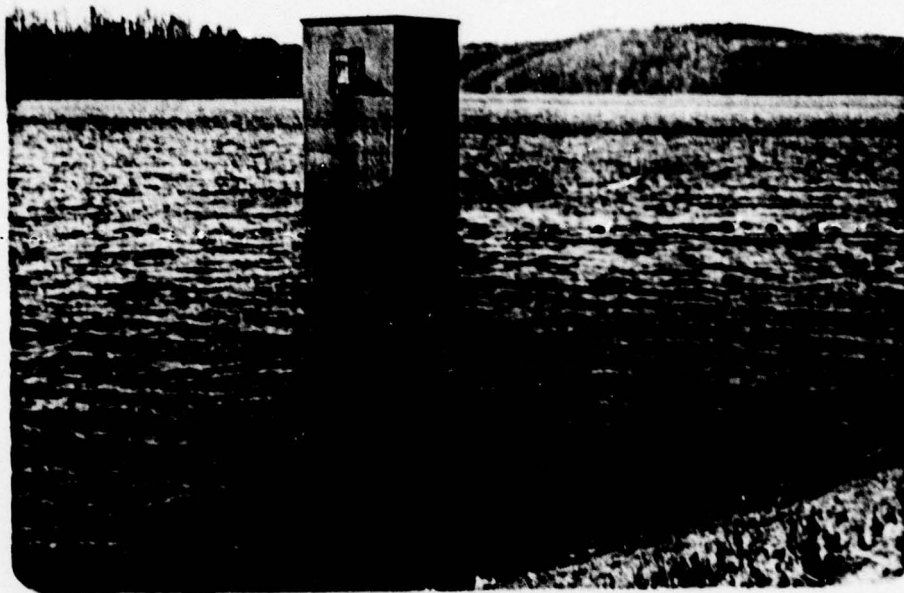
Water authority personnel reported that the access bridge to the control tower had partially collapsed and was removed. Therefore, the control tower was not accessible for inspection. Water authority personnel also reported that, to their knowledge, the outlet conduit sluice gate has not been operated since construction of the dam. The operation of the outlet conduit sluice gate was not observed.

Photograph No. 5  
Intake tower.

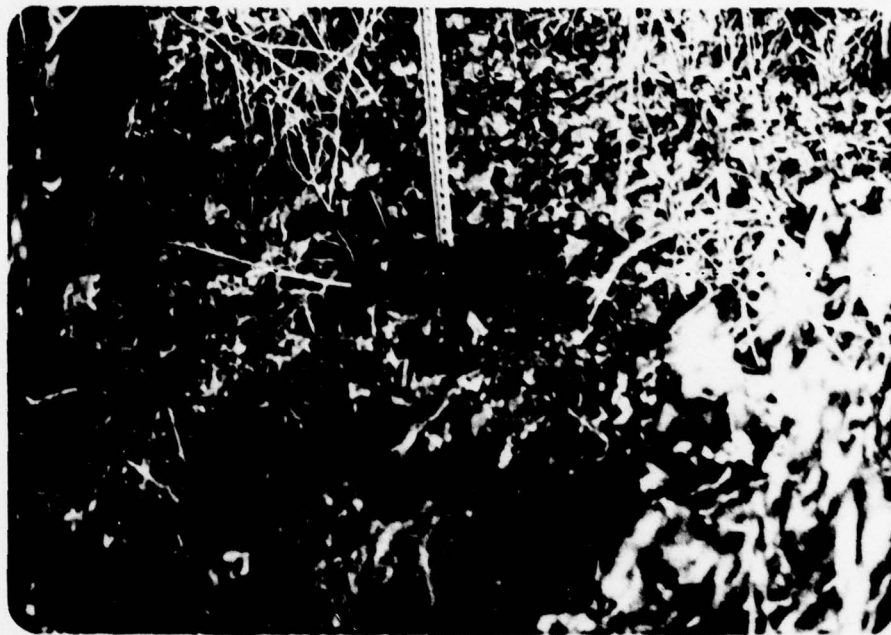
Numerous seepage points and wet areas were found below the toe of the dam and on the right and left abutments. Two major seepage points were identified. One is located at the toe level of the dam on the left abutment approximately 50 feet downstream from the toe of the dam. The other is located on the right abutment embankment interface approximately 20 feet upstream from the toe level of the dam. Flows in both seepage points were estimated to be on the order of 40 to 50 gallons per minute. Discharges were clear, indicating that seepage flows are not causing internal erosion of the embankment or foundation materials. The location of other seepage points discharging approximate 4 to 5 gallons per minute or less is identified on Plate 8. The swampy areas on the right and left abutments were found to be located mostly on the natural ground of the abutments and only partially reaching the junction of the embankment and abutments. While no seepage flow appeared to be associated with the swampy area on the left abutment, a flow of 4 to 5 gallons per minute was found to be discharging from the swampy area.

Photograph No. 7  
Boil on left abutment at toe level.

Numerous seepage points were observed below the toe of the dam. These seepage points should be monitored to determine if seepage flows are increasing.
